2015 Loch Lomond Summary Report

Lake County Health Department, Ecological Services

LLPOA Lake Committee - 2023

2015 Summary of Lake County Report on Loch Lomond

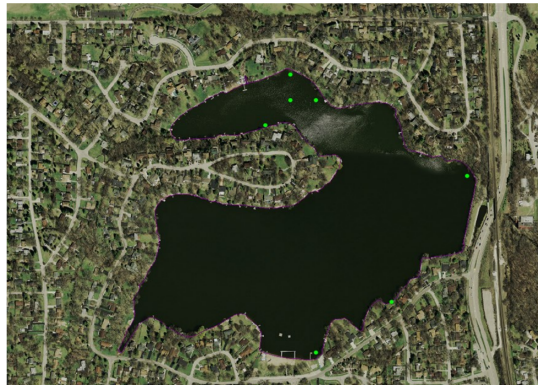
LOCH LOMOND AQUATIC PLANT MAP FOR JULY 2015

Only 8% of Loch Lomond sites observed contain aquatic plants, and a healthy lake needs 20-40%. The types of aquatic plants found, White Lily and Duckweed, are not high quality. Aquatic plants provide oxygen, reduce harmful nutrients like phosphorus which prevents algae, and stabilize sediments.

Aquatic Plants found at the 86 sampling sites on Loch Lomond Lake in July 2015. The maximum depth that plants were found was 4.7 feet.

- increase Wetland Buffers along the shoreline,
- plant emergent vegetation, and
- decrease carp populations.

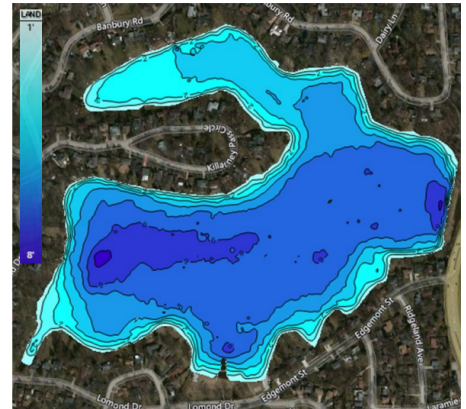
Bathymetric Map (Depth of Lake)

Bathymetric maps (depth contour maps) display the shape and depth of a lake. This information can then be used to determine the volume of the lake that goes anoxic, how much of the lake bottom can be inhabited by plants, and is essential in the application of whole-lake herbicide treatments, harvesting activities and alum treatments of your lake. Other common uses for the map include sedimentation control, fish stocking, and habitat management.

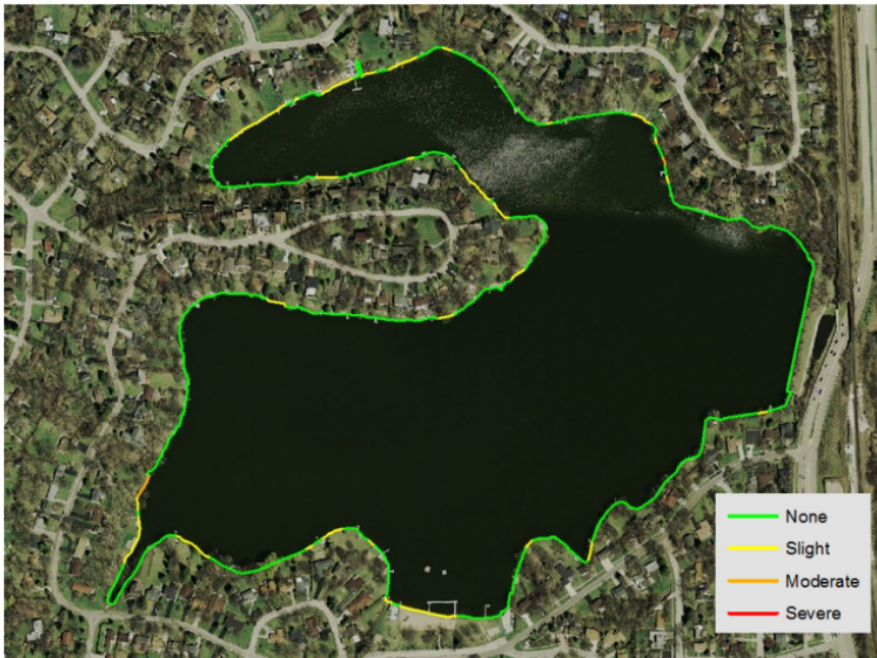
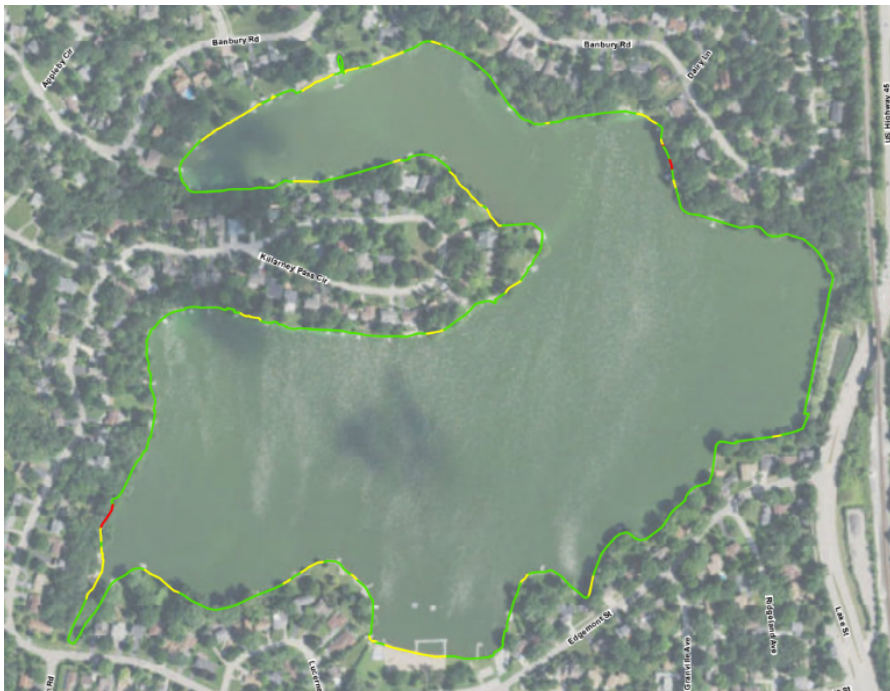
Erosion Maps

A **shoreline erosion study** was assessed for Loch Lomond in 2015. The shoreline was divided into reaches, and the evaluated for none, slight, moderate and severe erosion based on exposed soil and tree/plant roots, failing infrastructure, undercut banks, and other signs of erosion. Based on the 2015 data, **23.4% of Loch Lomond's shoreline has some erosion which is up 67% since 2005. Approximately 19% of the eroding shoreline was classified as slightly eroding, with the remainder classified as moderately eroding (1.2%) and severely eroding (2.6%).** Continued neglect of these shorelines could lead to further erosion, resulting in a loss of property, and added soil inputs into the water that negatively affect water clarity.

Erosion is a natural process primarily caused by water which results in the loss of material from the shoreline. Disturbed shorelines caused by human activity such as clearing of vegetation and beach rocks, and increasing runoff will accelerate erosion. Rain and melting snow and wave action are the main causes of erosion. Rain can loosen soil and wash it down gradient towards the lake. **Creating a native plant buffer helps prevent soil erosion as well as filter out pollutants and unwanted nutrients from entering the lake. Native plants can be planted along the shoreline** since plant roots hold the soil particles in place so they are not easily washed away during a rain event, melting snow or wave action. Loose rocks and gravel placed on top of a filter fabric prevents soil from washing away before newly planted seed and vegetation has a chance to grow. Eroded materials cause turbidity, sedimentation, nutrients, and pollutants to enter a lake. Shore line buffer zones planted with native vegetation not only reduces runoff by increasing water infiltration into the ground, it also offers food and habitat for wildlife. Less runoff means less nutrients, sediments and other pollutants entering the lakes and streams. Excess nutrients are the primary cause of algal blooms and increased aquatic plant growth. Once in the lake, sediments, nutrients and pollutants are harder and more expensive to remove.

Stone refacing is adding layers of stone in front of an existing seawall to create a more natural shoreline. The stones help absorb wave energy that would otherwise reflect back and scour the bottom of the lake. This provides excellent habitat for fish, turtles and other aquatic animals. This minimizes the negative effects of an inflexible vertical seawall. Permits may be required with local or state government agencies prior to any alteration or repair of shoreline.

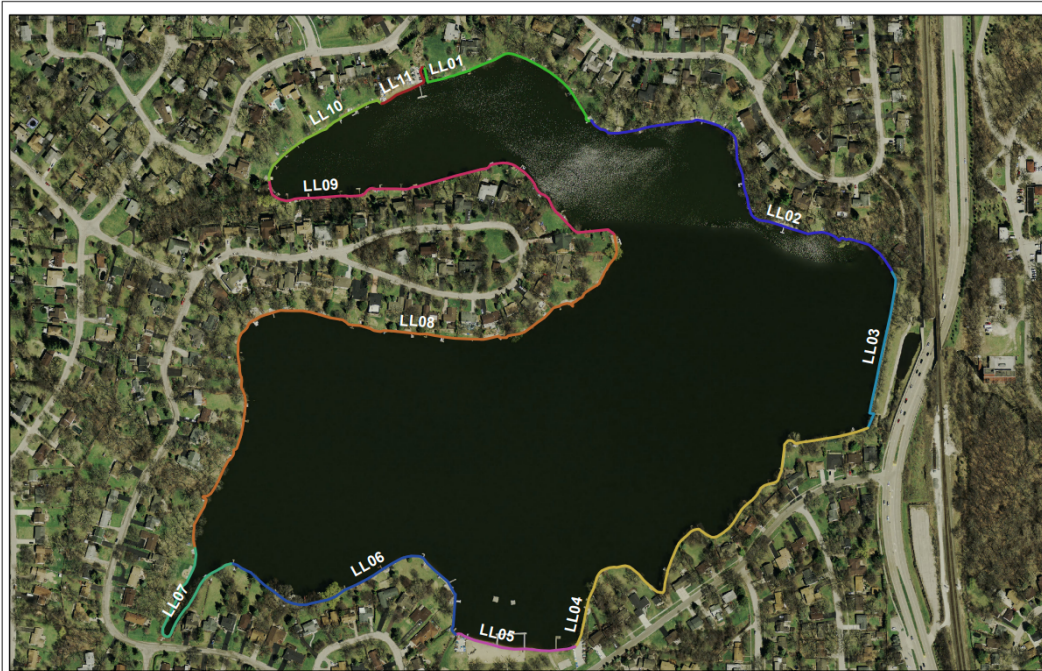
Loch Lomond Shoreline Reaches 2015

Table 1: Loch Lomond Shoreline Erosion Condition 2015

Reach	None		Slight		Moderate		Severe		Total	Lateral Recession Rate
	Linear ft.	% Reach	Linear ft.	% Reach	Linear ft.	% Reach	Linear ft.	% Reach		
LL01	602.8	72.9	223.7	27.1	0.0	0.0	0.0	0.0	826.5	0.020
LL02	1294.4	71.2	155.1	8.5	49.7	2.7	318.0	0.0	1817.1	0.025
LL03	629.6	100.0	0.0	0.0	0.0	0.0	0.0	0.0	629.6	0.010
LL04	1593.8	91.1	155.4	8.9	0.0	0.0	0.0	0.0	1749.2	0.020
LL05	231.8	48.6	245.3	51.4	0.0	0.0	0.0	0.0	477.2	0.025
LL06	829.1	70.7	343.9	29.3	0.0	0.0	0.0	0.0	1173.0	0.020
LL07	571.8	75.5	186.0	24.5	0.0	0.0	0.0	0.0	757.8	0.010
LL08	2242.0	85.0	304.0	11.5	93.0	3.5	0.0	0.0	2639.0	0.020
LL09	1119.4	73.9	394.6	26.1	0.0	0.0	0.0	0.0	1514.0	0.010
LL10	266.9	47.7	292.3	52.3	0.0	0.0	0.0	0.0	559.2	0.025
LL11	104.1	42.3	142.0	57.7	0.0	0.0	0.0	0.0	246.0	0.010
Total	9485.6	76.6	2442.3	19.7	142.7	1.2	0.0	0.0	12388.7
