# LOCH LOMOND

## LONG TERM LAKE AND WATERSHED MANAGEMENT PLAN

FOR THE  
LOCH LOMOND PROPERTY OWNERS ASSOCIATION

September 24, 2018

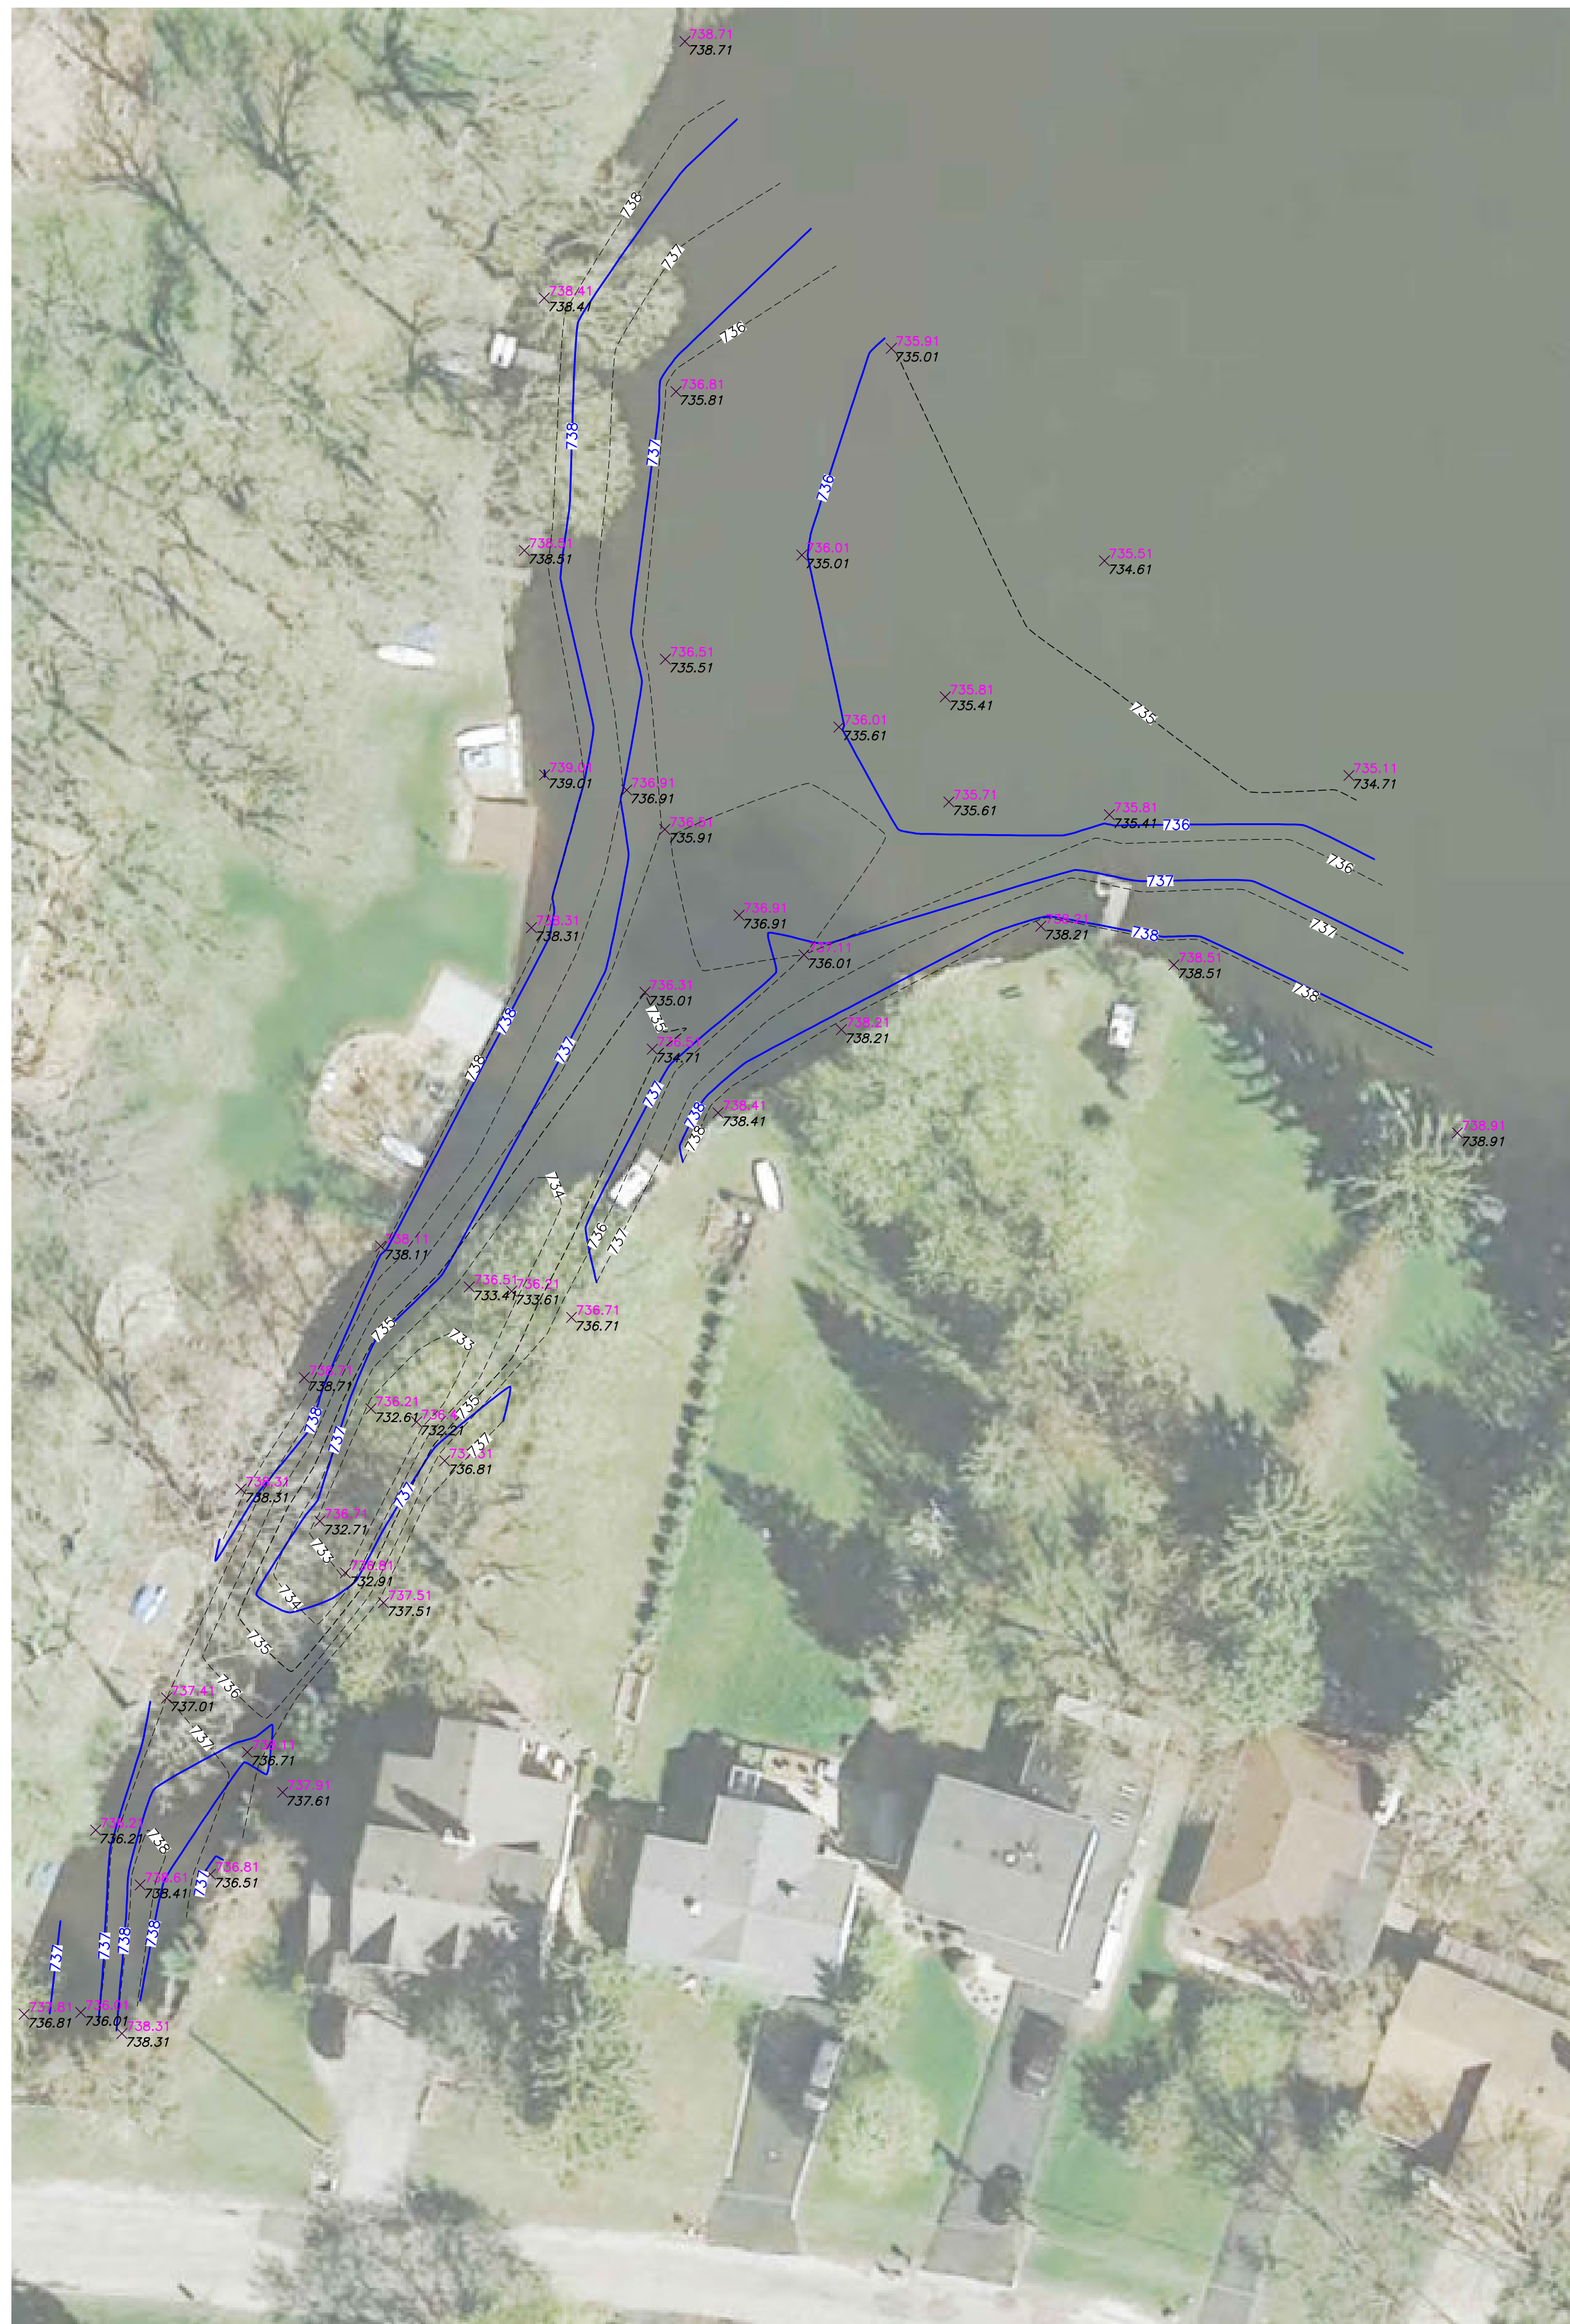
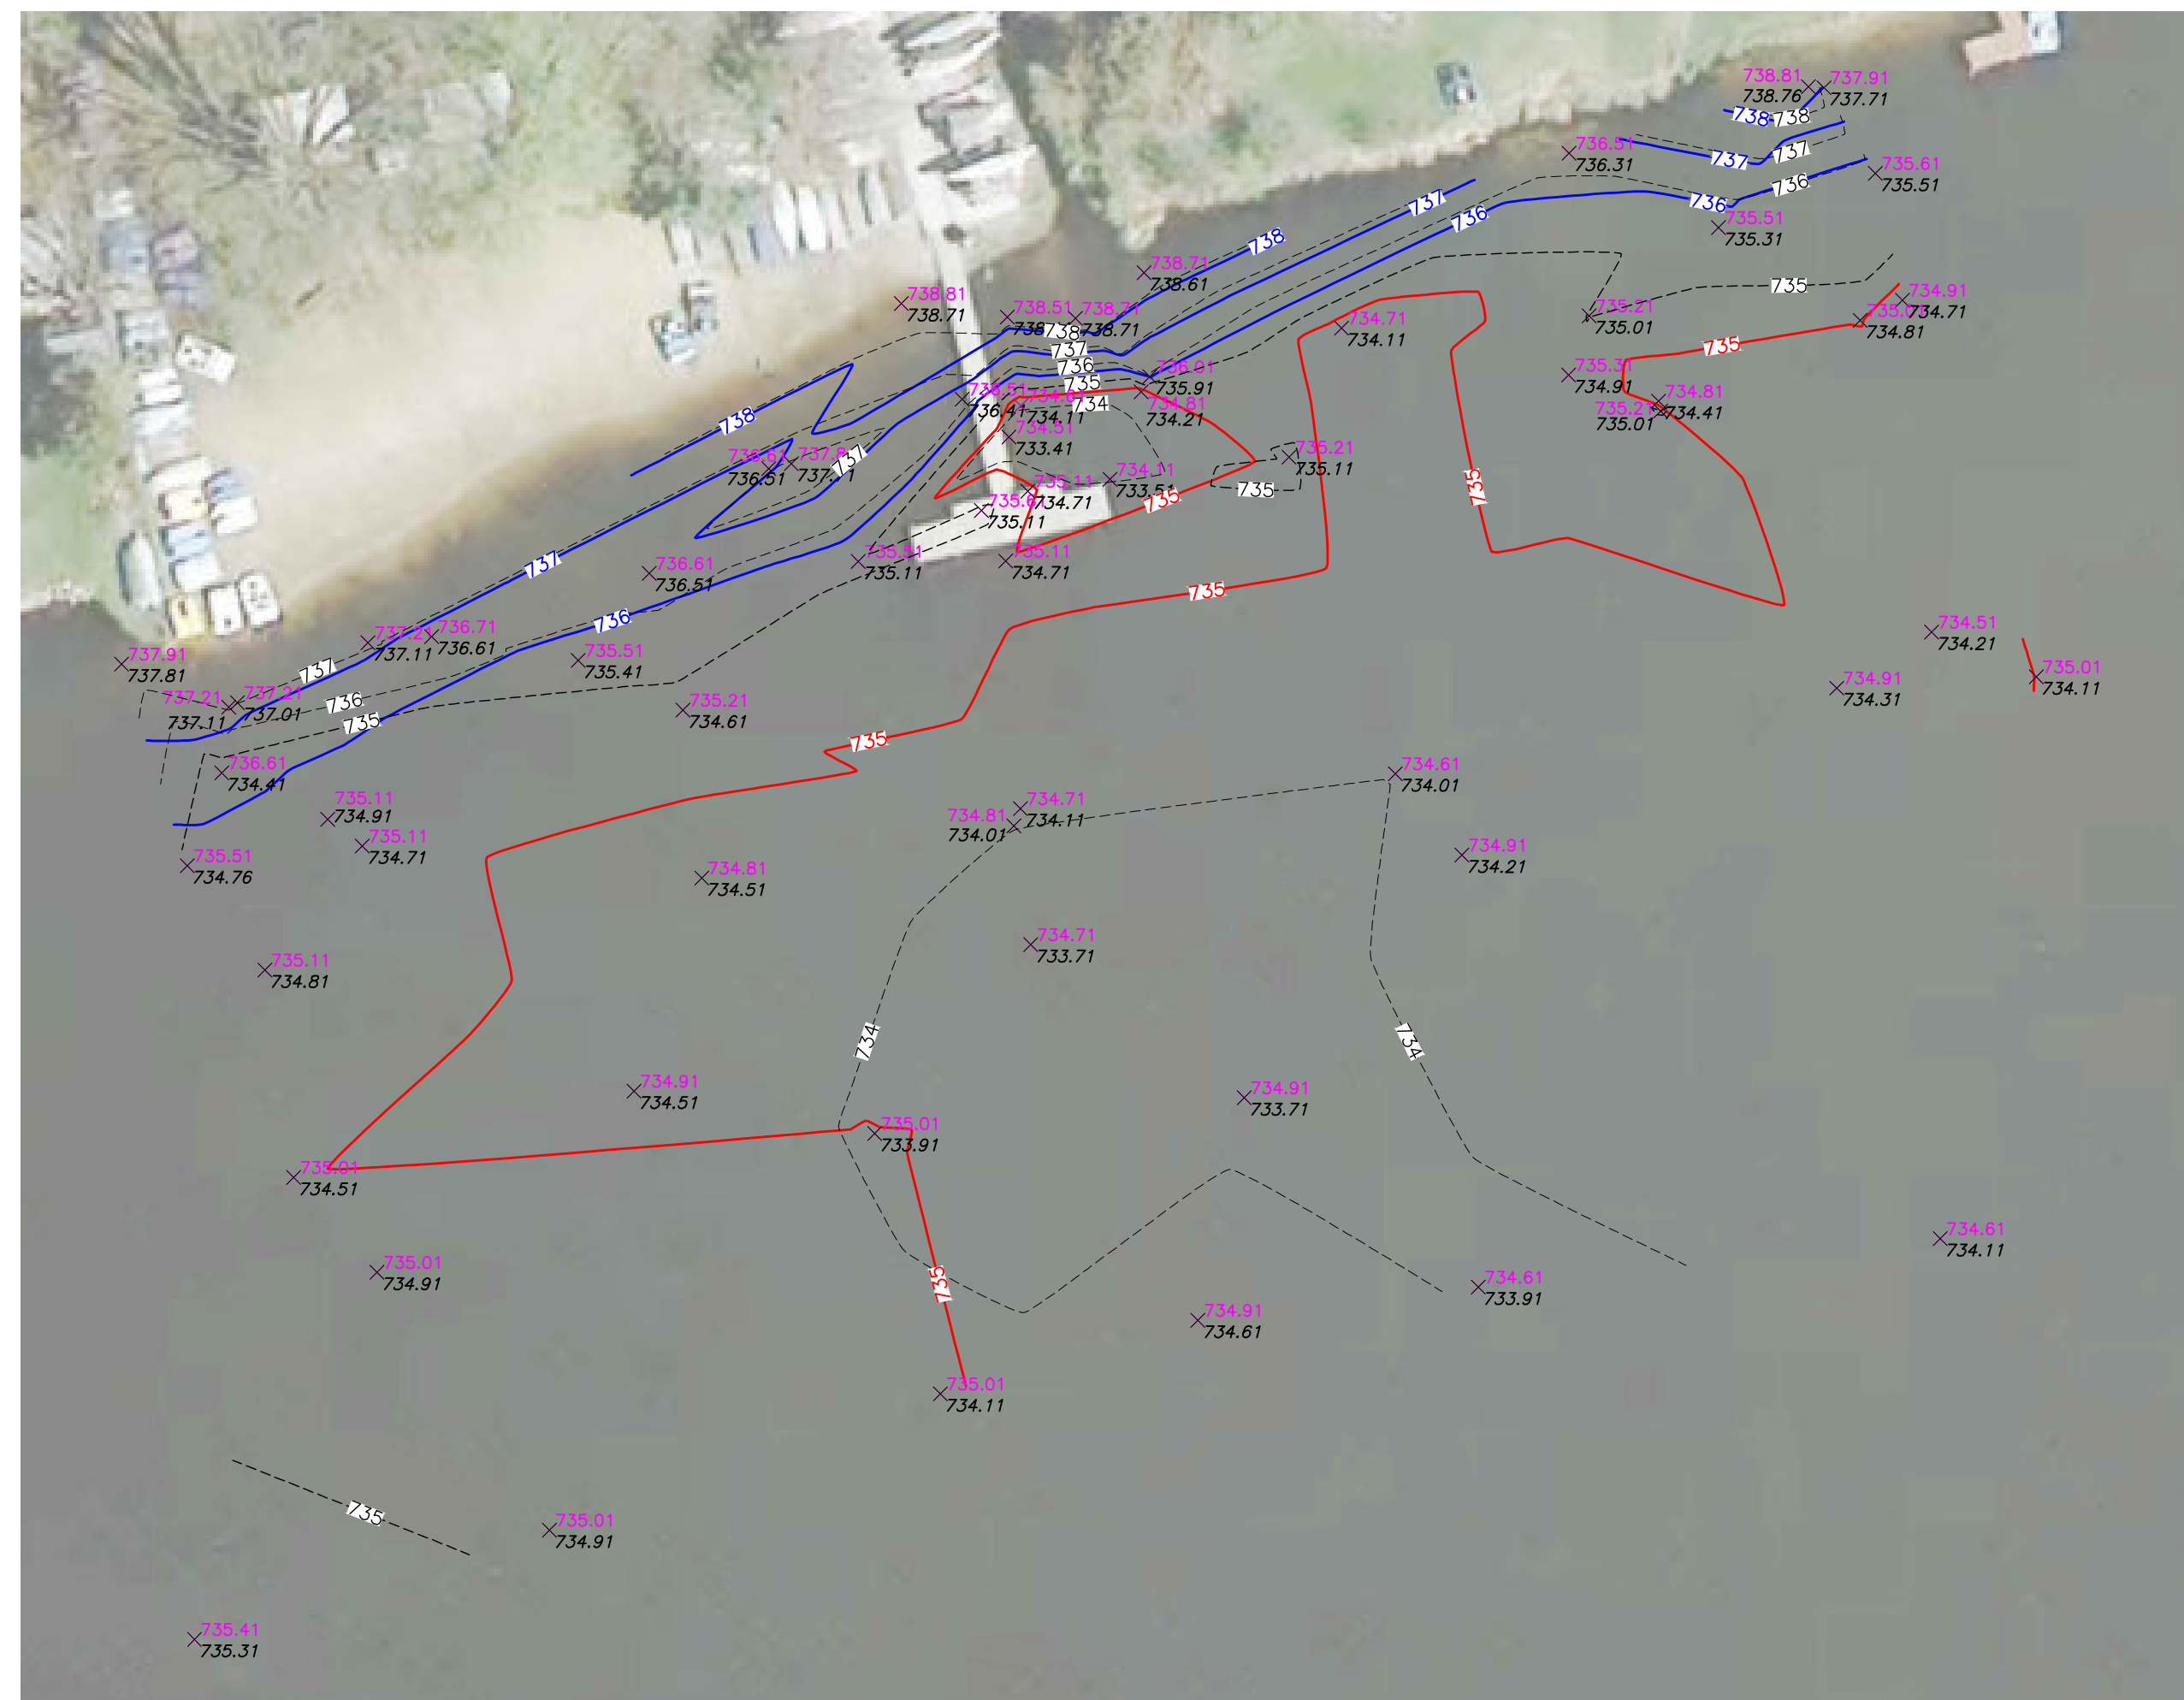
**Exhibit 4**  
**Bathymetry 1**

①

Inlet 1

②

North Beach

Survey was performed to measure both the soft sediment and hard bottom contours at Inlet 1, North Beach, and South Beach. Soft sediment contours, hard sediment contours, survey elevations, and estimates of soft sediment volume are included in Exhibits 4 and 5. Hey has concluded that there is no current need for dredging at any of these sites. Current sediment depths do not appear to be at levels that would warrant removal and are likely not a large contribution to nutrient loading.

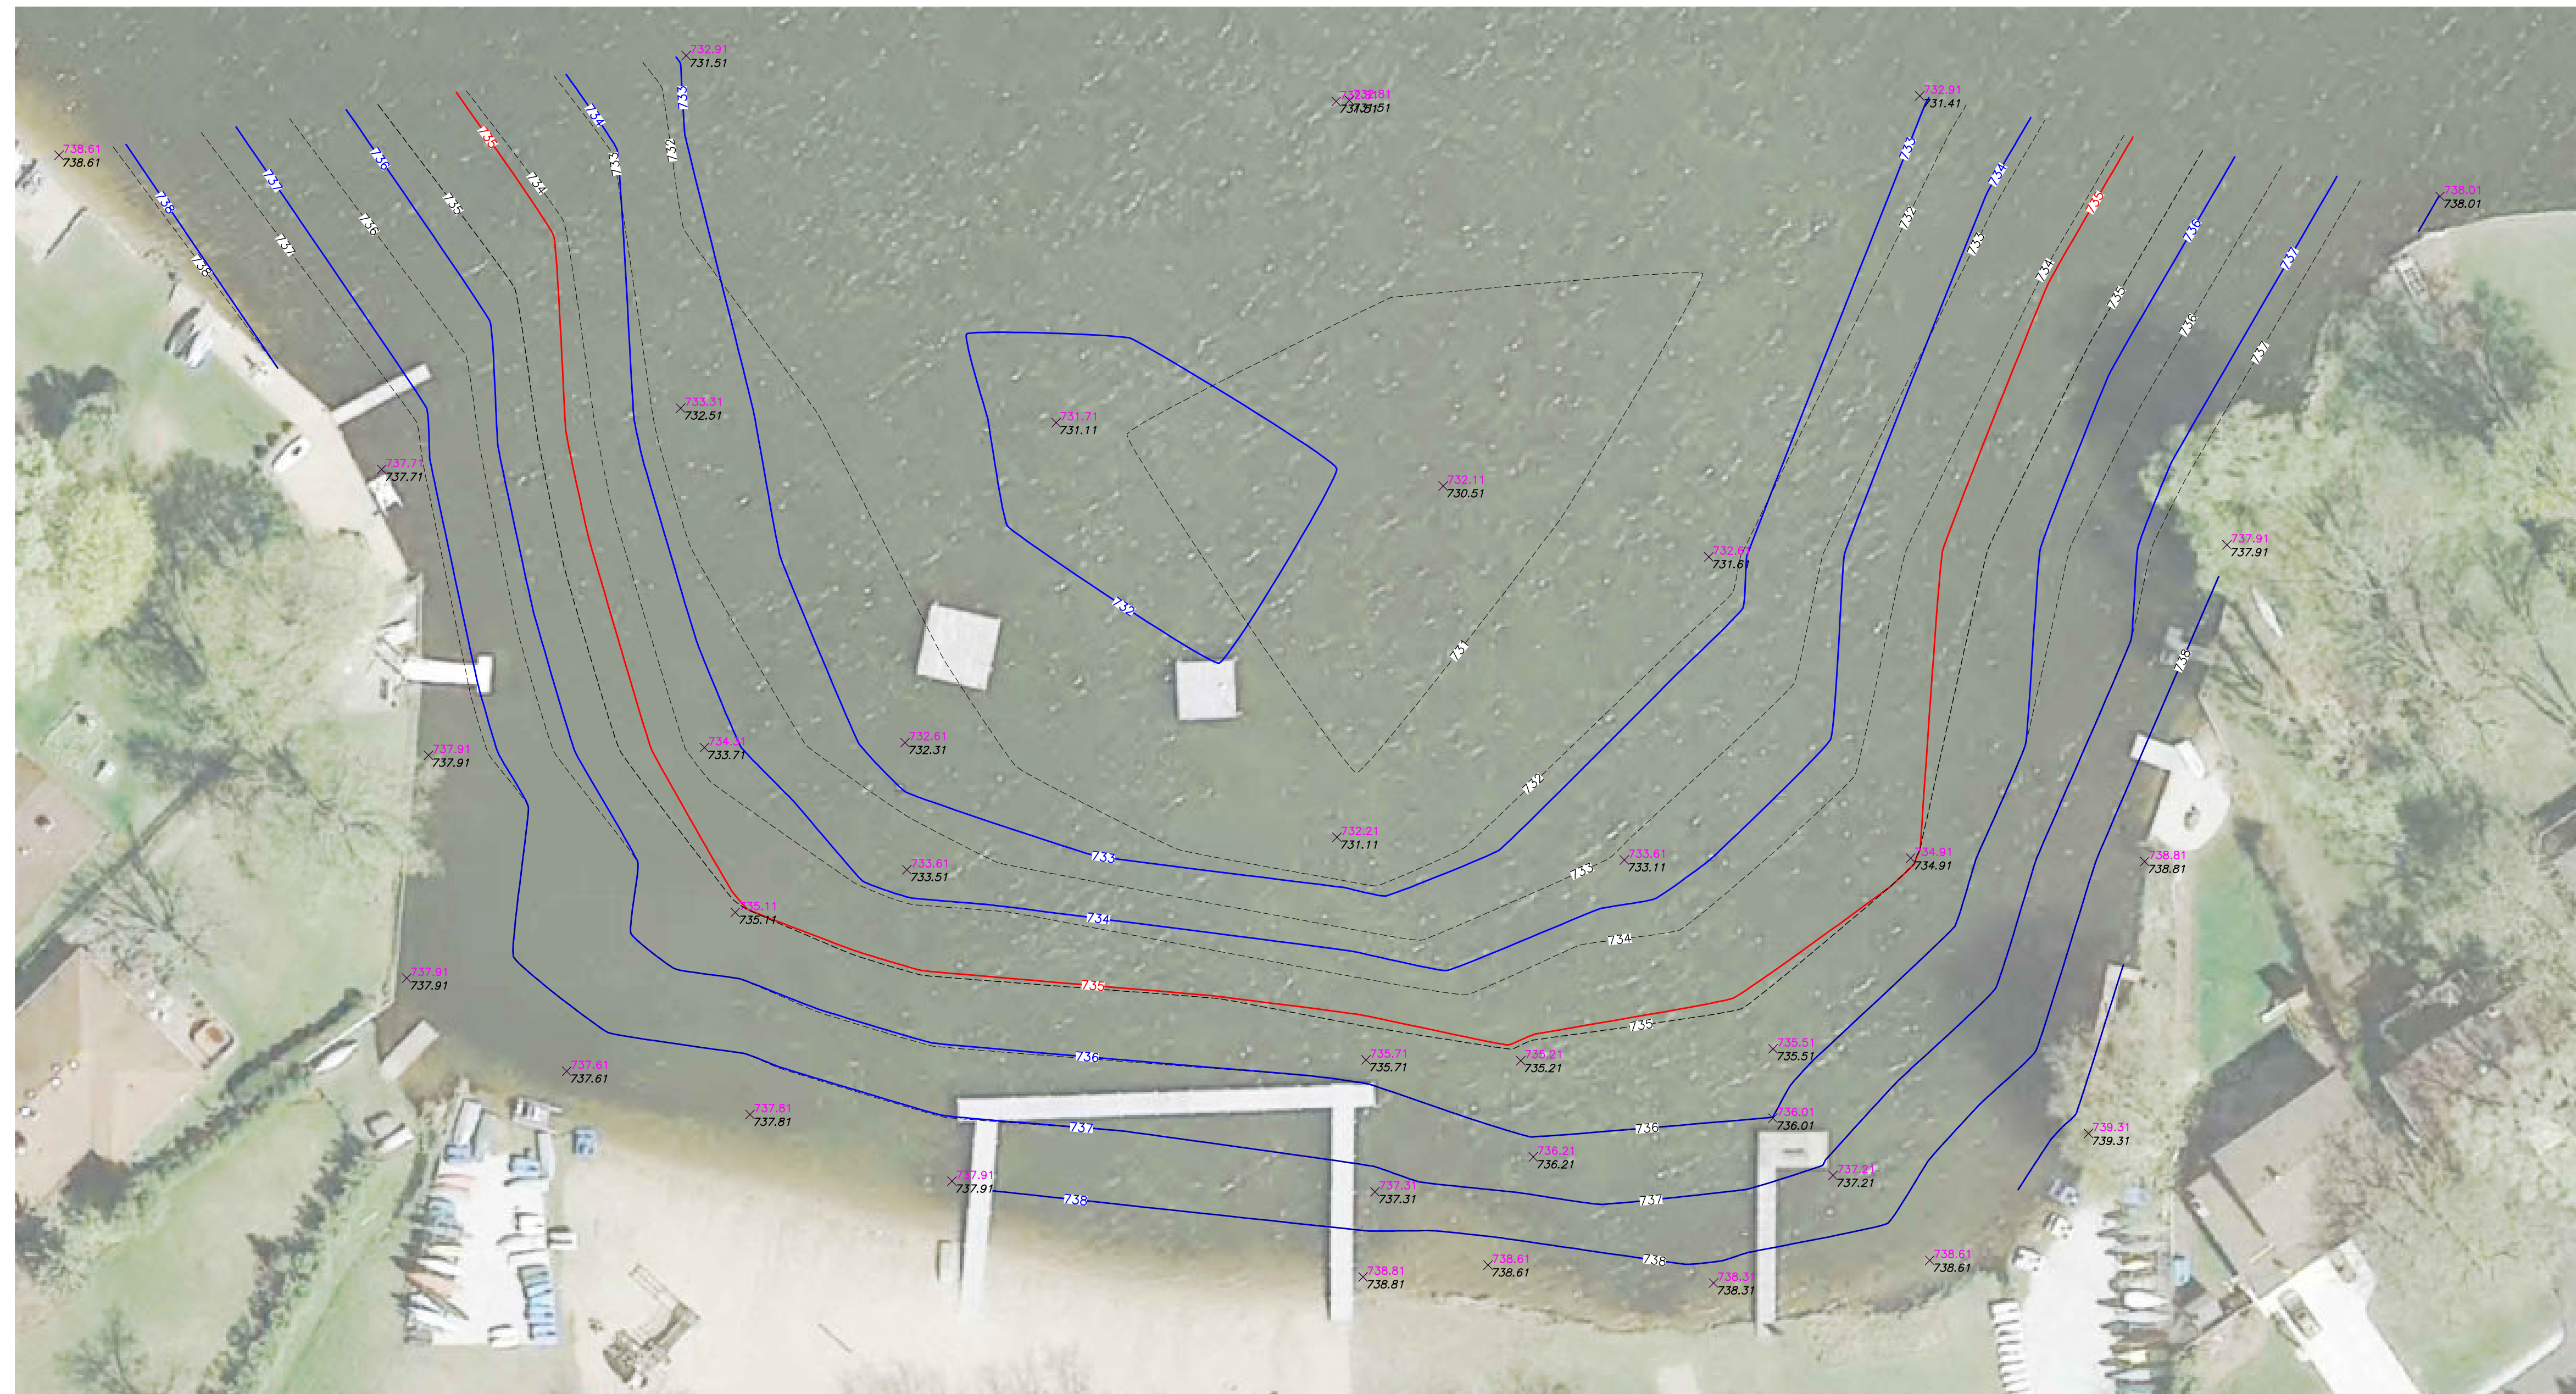
**Exhibit 5**  
**Bathymetry 2**

Bathymetric Survey  
 South Beach

① ————— South Beach

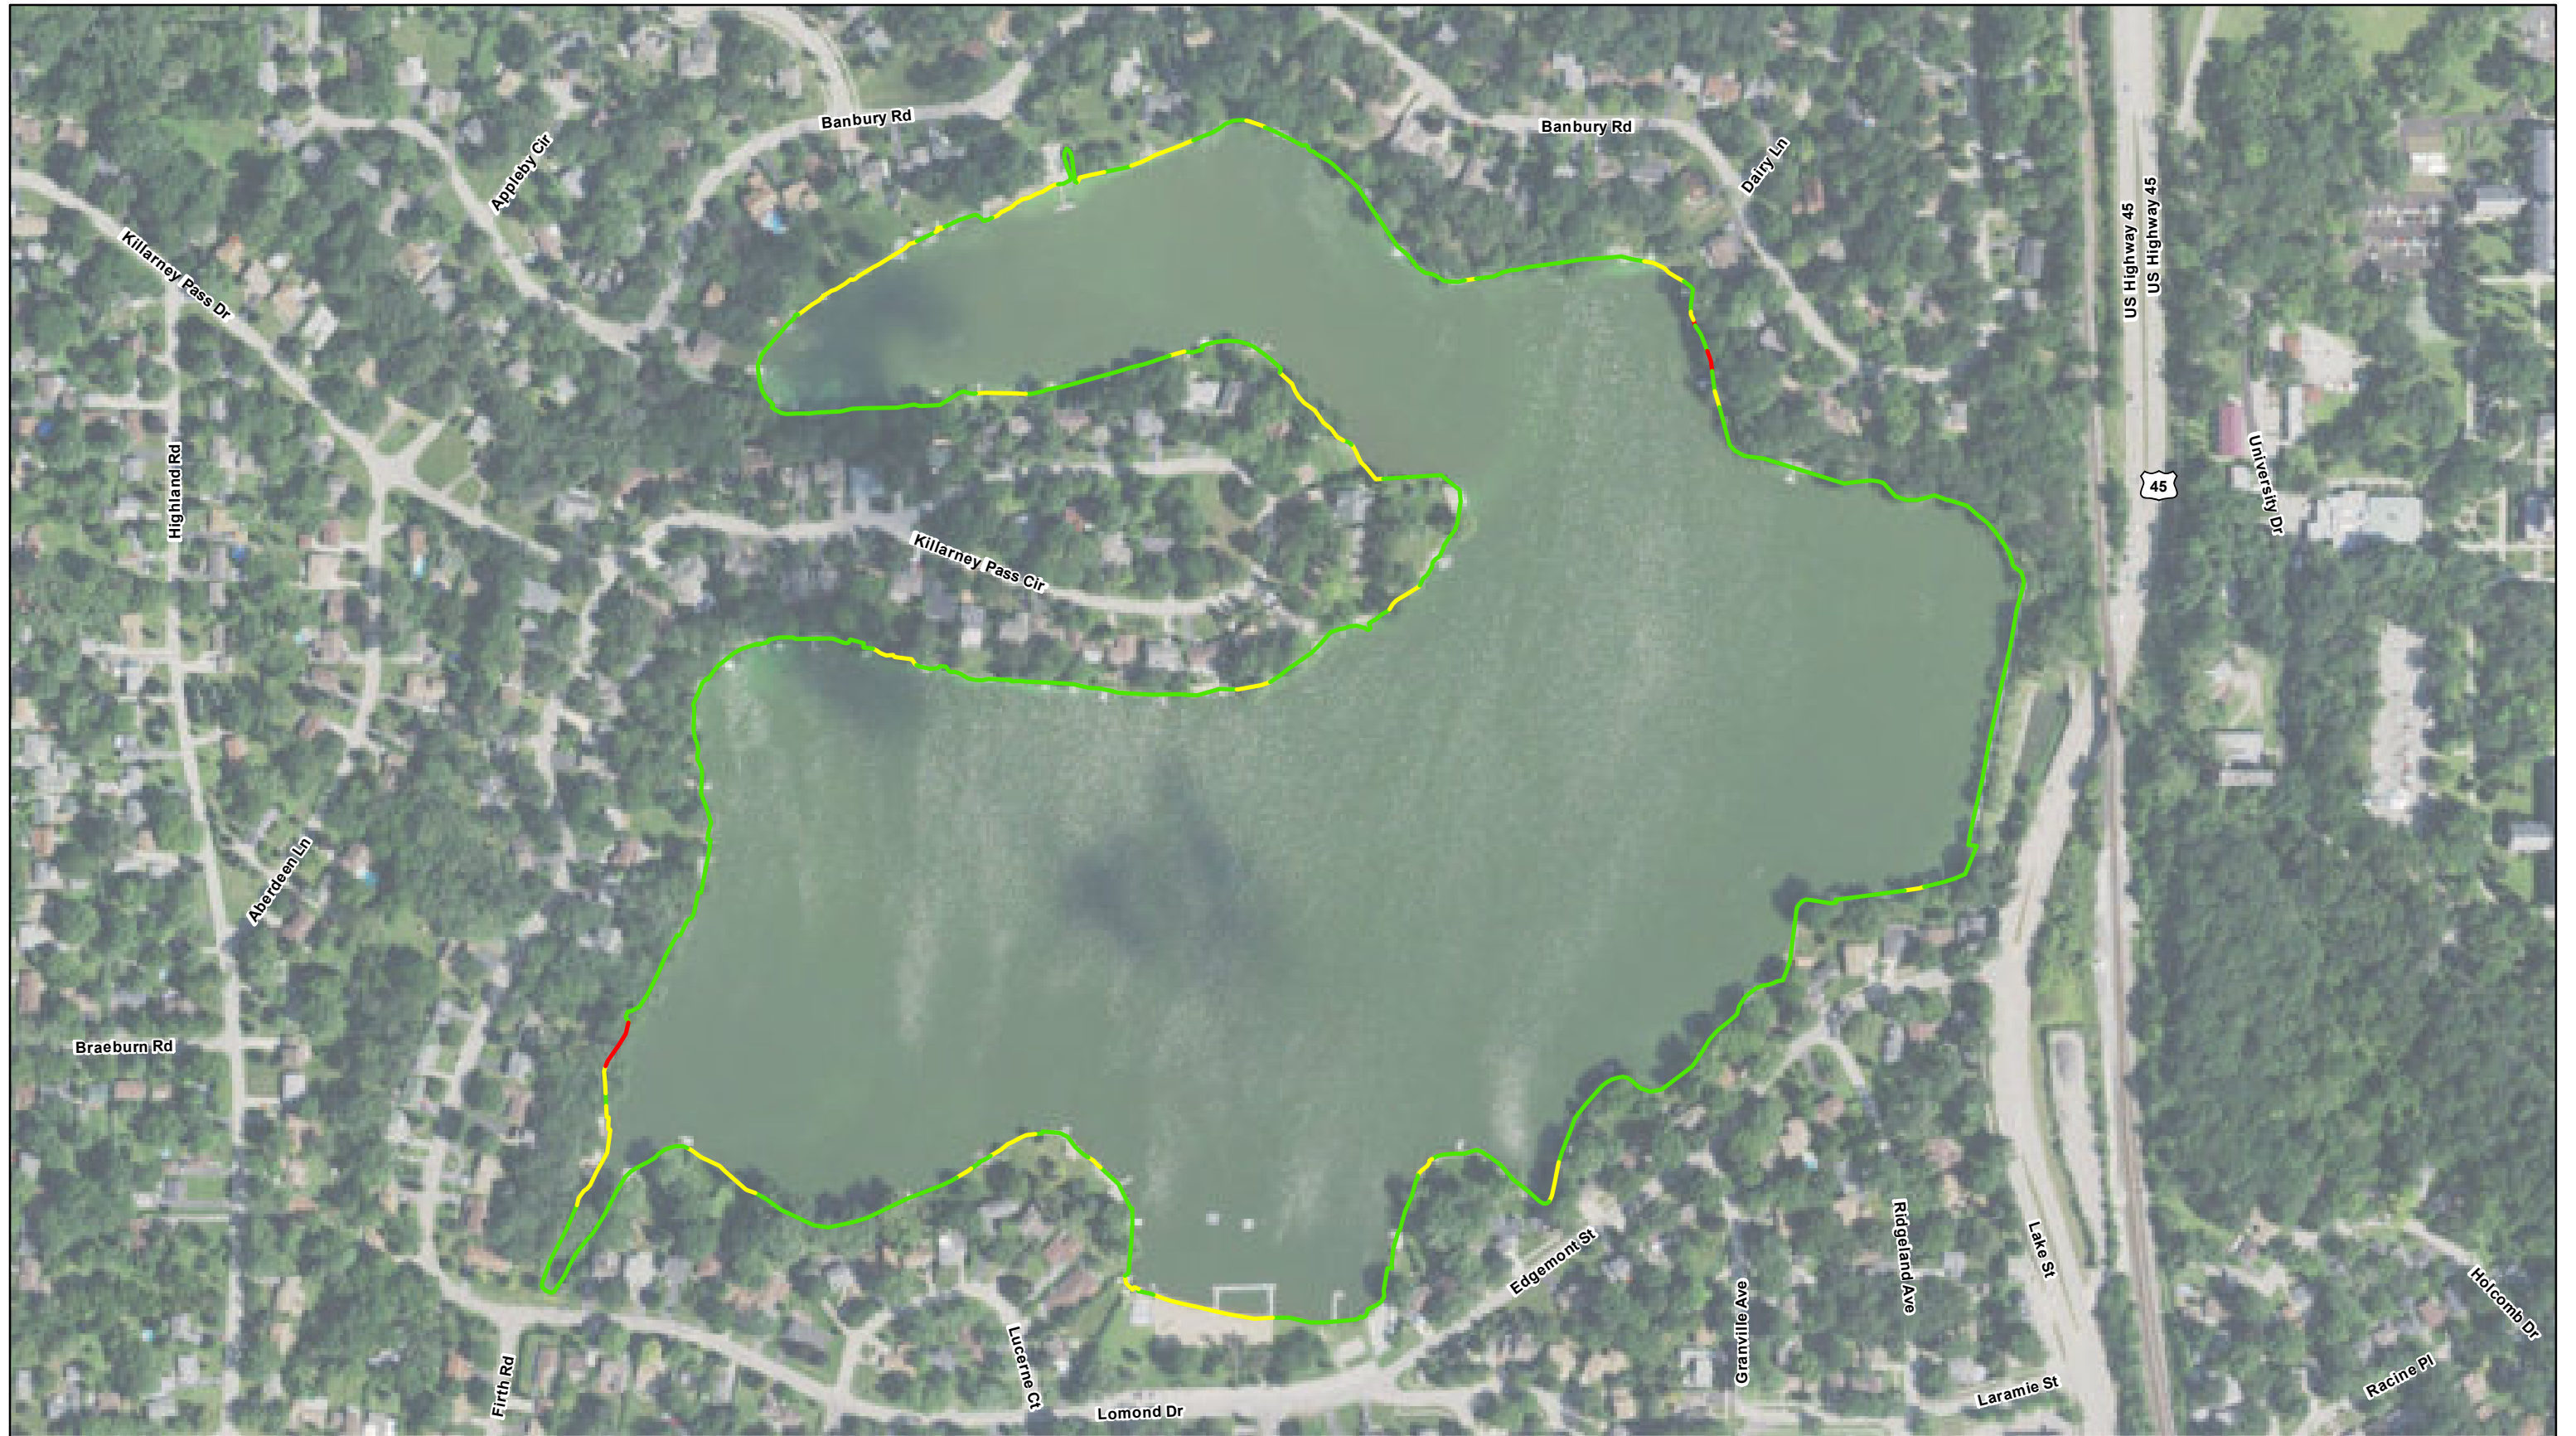
**Exhibit 6**

**Shoreline Erosion**

A shoreline erosion assessment was also performed by Hey in 2017 to document current shoreline conditions on Loch Lomond. The majority of the shoreline is relatively stable; most lots have engineered stabilization practices. Stable shoreline characterization includes sheet pile, riprap, and concrete structures, while lesser stable shorelines are comprised of sparse riprap and yards mowed down to the water line. The results of this erosion assessment are included as Exhibit 6.

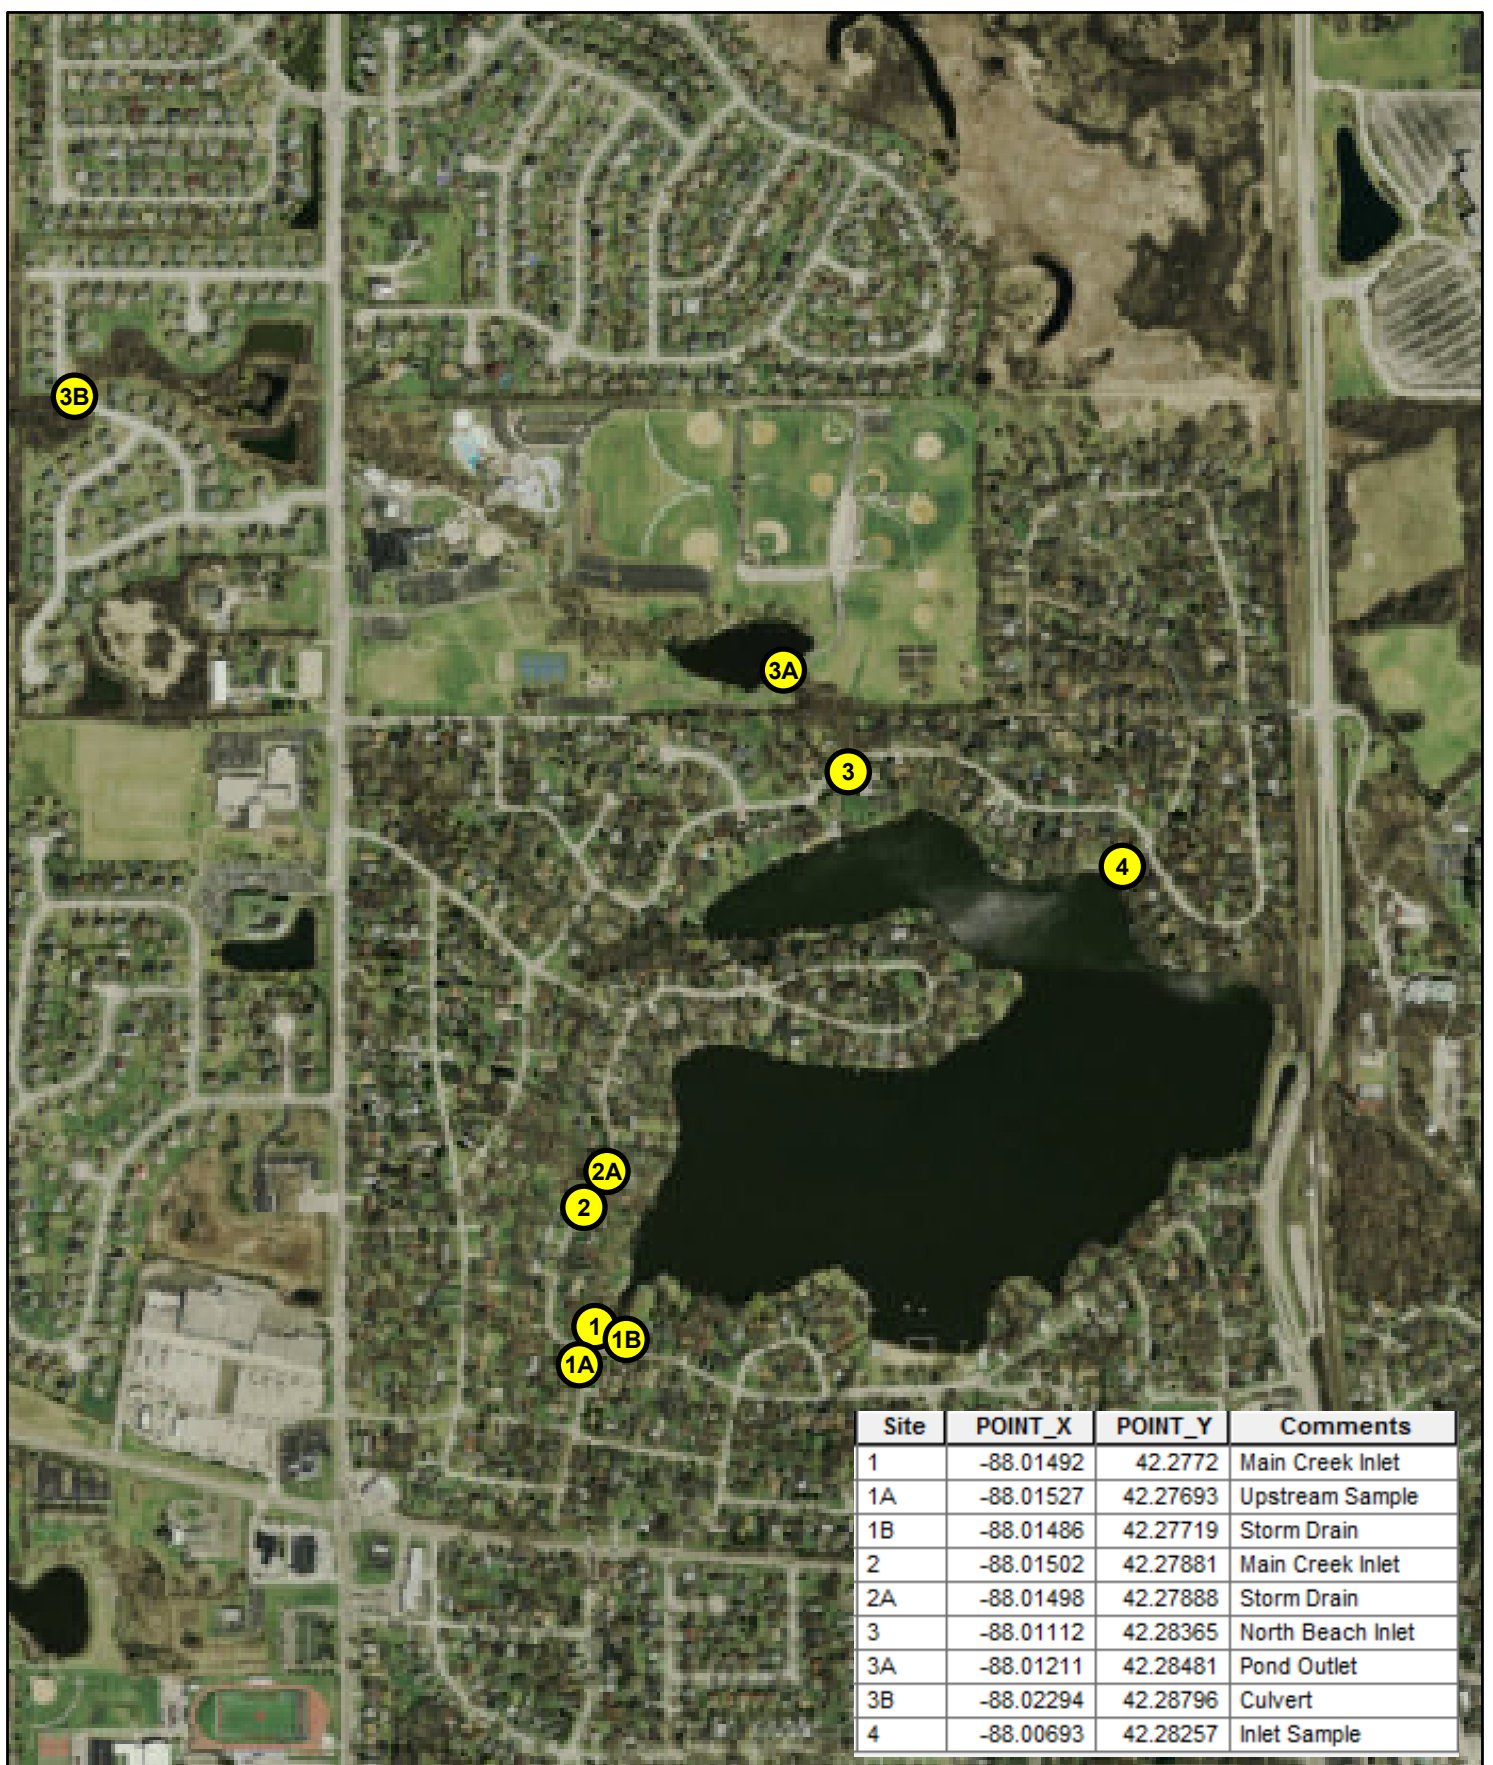
**Sampling Locations**

# Loch Lomond Sampling Sites 2016-2017

Site	POINT_X	POINT_Y	Comments
1	-88.01492	42.2772	Main Creek Inlet
1A	-88.01527	42.27693	Upstream Sample
1B	-88.01486	42.27719	Storm Drain
2	-88.01502	42.27881	Main Creek Inlet
2A	-88.01498	42.27888	Storm Drain
3	-88.01112	42.28365	North Beach Inlet
3A	-88.01211	42.28481	Pond Outlet
3B	-88.02294	42.28796	Culvert
4	-88.00693	42.28257	Inlet Sample

Hey recommended additional sampling sites and the LCHD completed sampling at the locations included in Exhibit 7 from May to September 2017. A table and figures of the results are included below. Figure 1 illustrates the influence of major runoff events on Inlet 3 phosphorus loadings, as shown by the sample results following the July 12017 storm event.
