# LOCH LOMOND

## LONG TERM LAKE AND WATERSHED MANAGEMENT PLAN

FOR THE  
LOCH LOMOND PROPERTY OWNERS ASSOCIATION

September 24, 2018

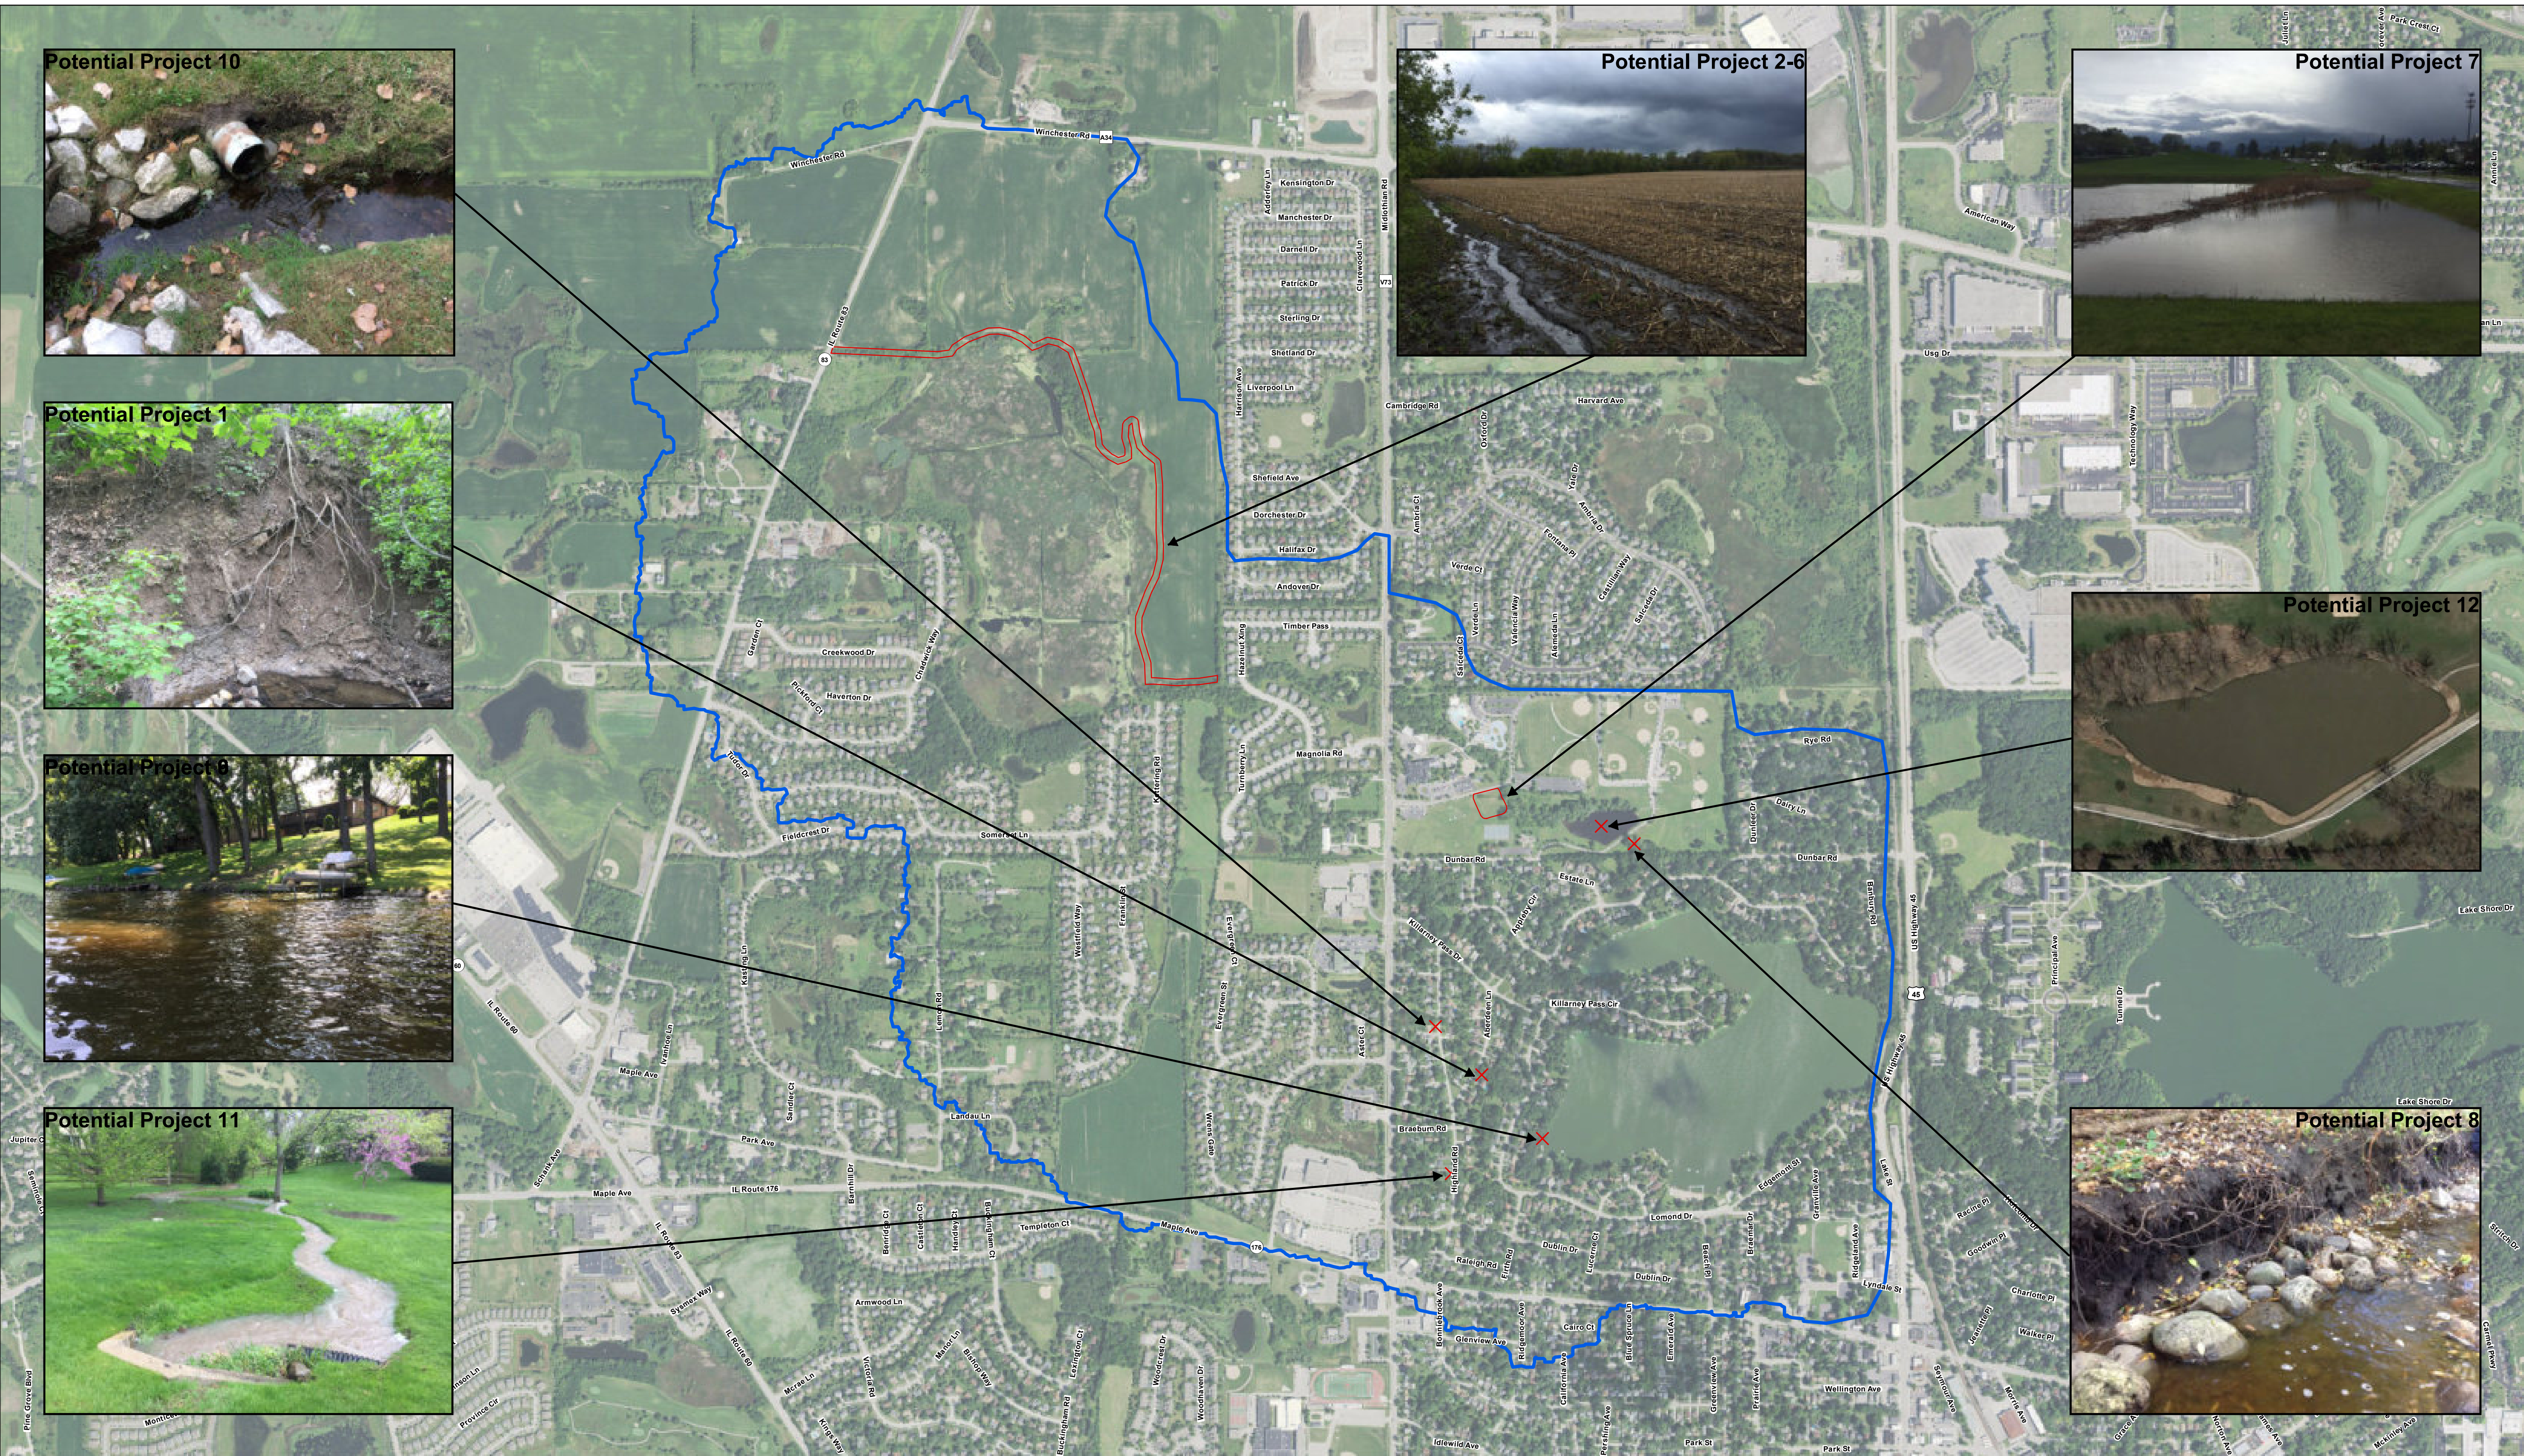
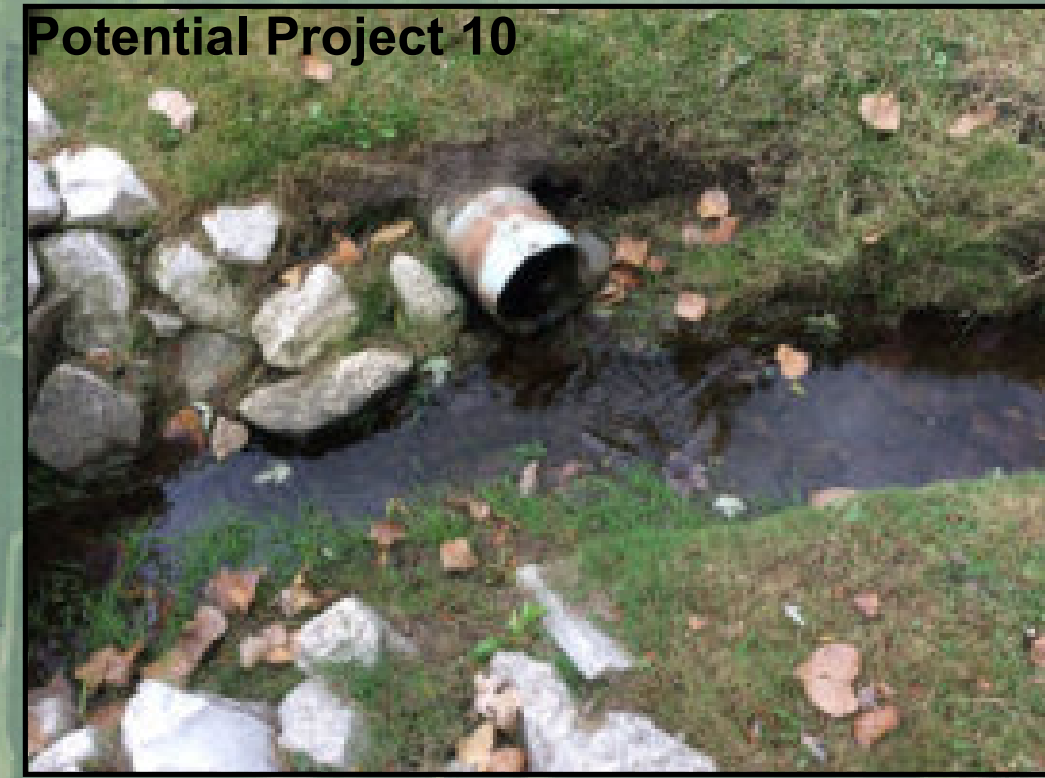
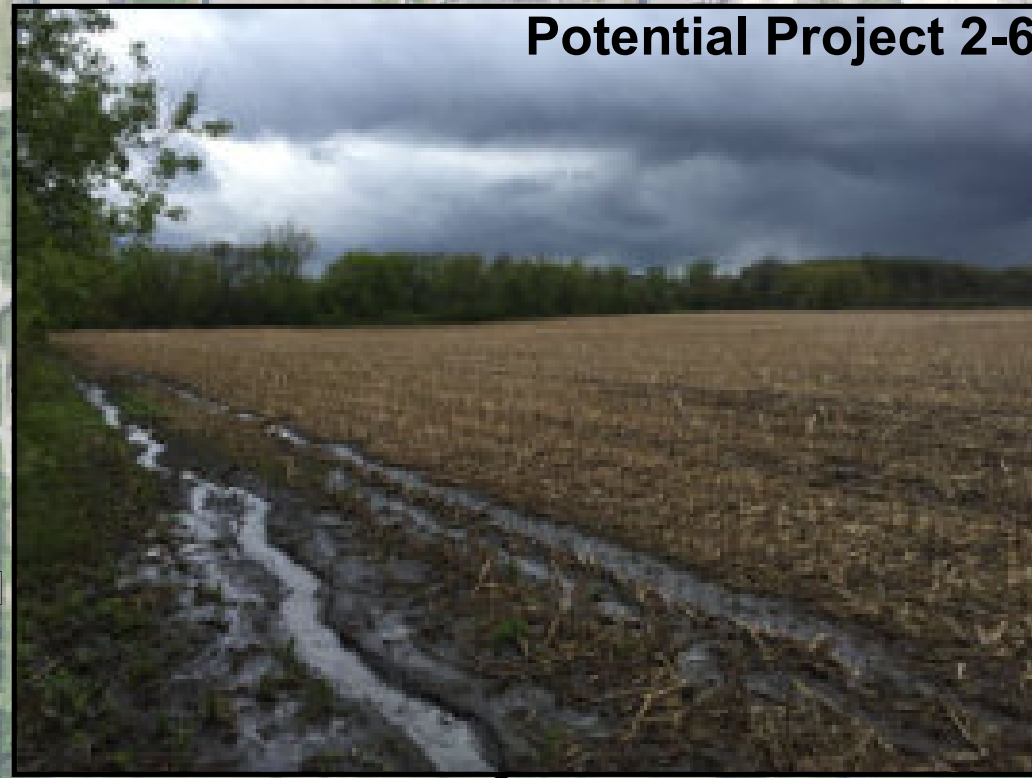
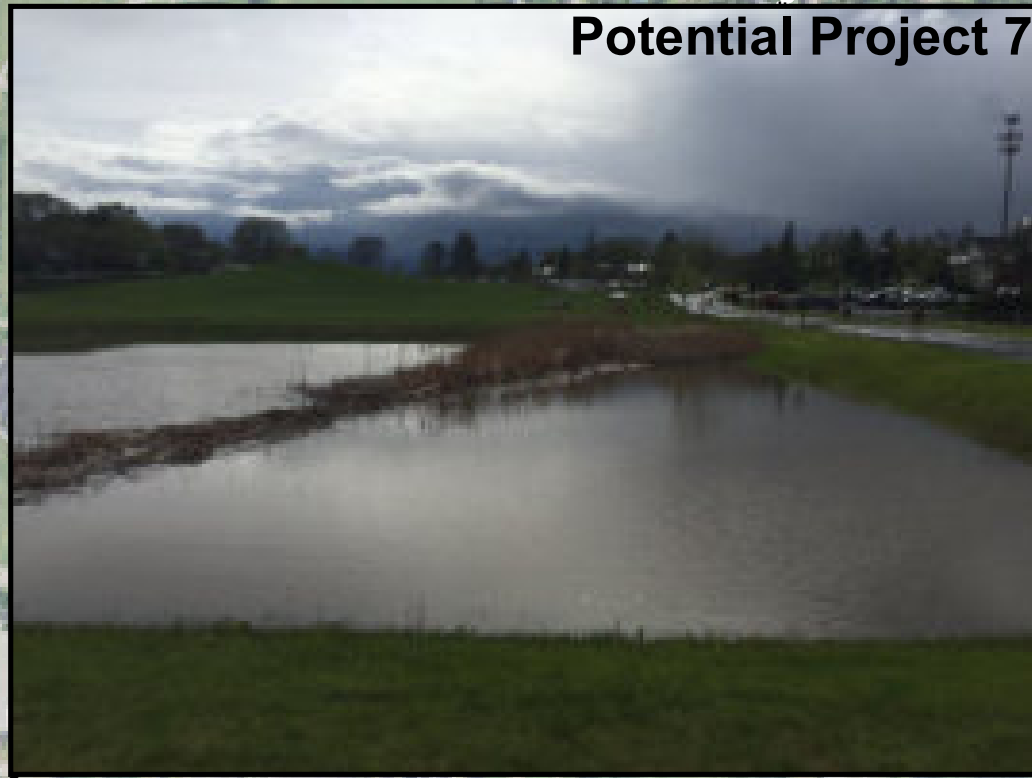
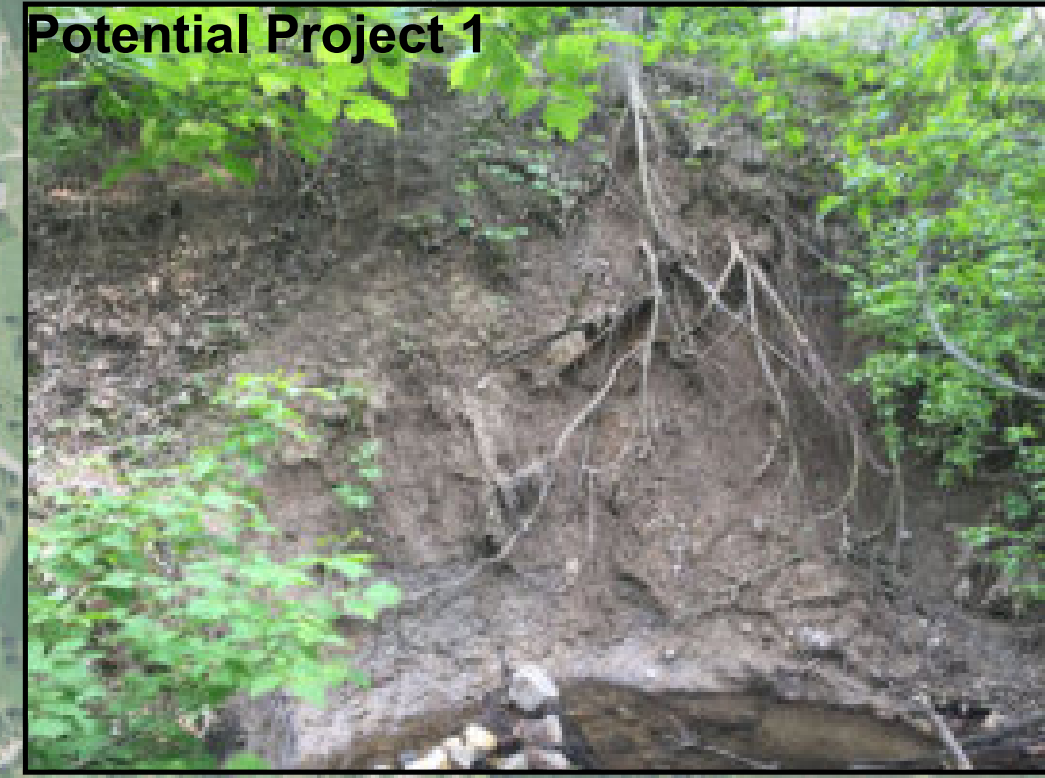
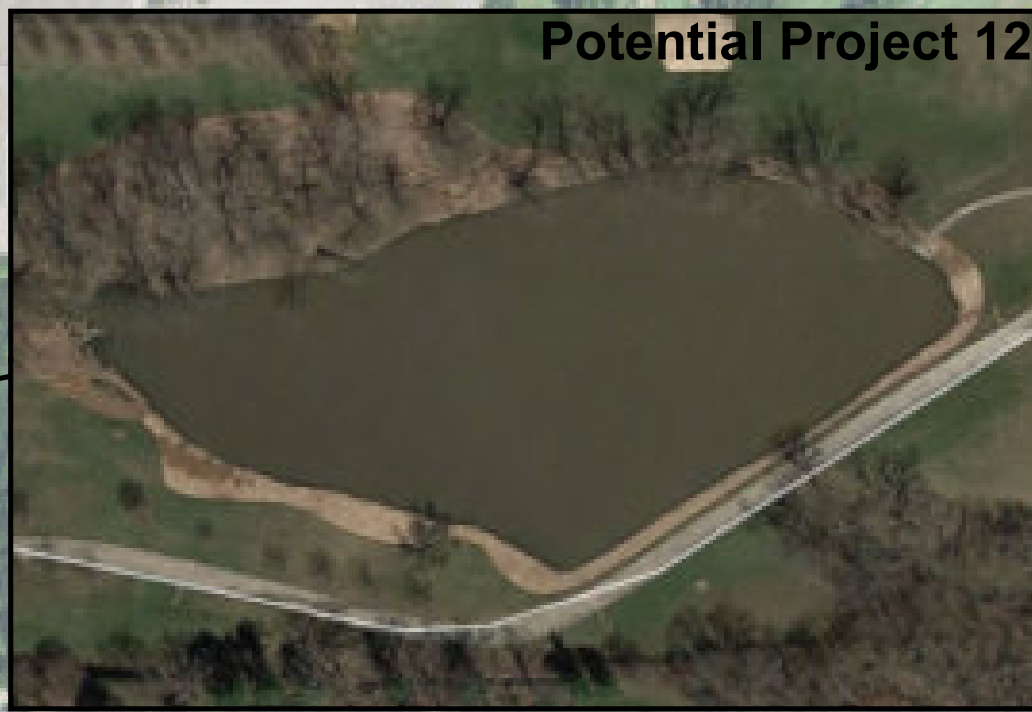
**Exhibit 8**

**Potential Improvements**

Following review of available data to begin to assess stream and watershed characteristics, a reconnaissance of the upstream waterway network was performed in the Summer of 2017 to determine existing conditions and identify issues. The reconnaissance included a visit to the upper watershed after significant rainfall to observe how water traveled through the watershed. As part of the LCSMC, a similar assessment was performed in 2015. During the 2017 reconnaissance, the 2015 stream inventory was used as a baseline for comparison. Representative photos of findings are included in Exhibit 8.

This location, on parcel number 10-24-106-008, was noted both during the Hey field reconnaissance and the LCSMC stream inventory as having severe erosion. A photo is included on Exhibit 8. This channel side slope is characterized by steep banks and thick canopy cover. Proposed improvements include grading banks to a more natural slope, installing stone toe protection, installing erosion control blanket, and planting native vegetation to stabilize banks. Surrounding trees would be selectively thinned to promote success of ground vegetation. The model suggests that implementation of this project could potentially remove 3.2 pounds of phosphorus per year; reducing the loading by 0.7%.

A 50-foot wide (NRCS recommended width) vegetated buffer strip is shown on Exhibit 8. This riparian buffer is designed to span the length of the wetlands complex, as it is adjacent to the upstream agricultural field located to the north and east. The agricultural land south of Winchester Road and east of Route 83 is approximately 121 acres. The parcel numbers associated with the field are 10-14-200-001, 10-14-400-002, 10-14-200-008, 10-14-200-002, 10-14-200-005, and a road right-of-way. This buffer is calculated to be approximately 7 acres in size and would capture sediment and nutrients from field runoff prior to them entering the wetland. Other options for improvements for these 121 acres of farmland are included as Projects 3-6. The model suggests that implementation of this project could potentially remove 15.3 pounds of phosphorus per year; reducing the loading by 3.3%.

As shown on Exhibit 8, the banks directly downstream from the Keith Mione Community Park Pond, located on parcel number 10-13-300-046, are bare and vertical. This section of channel was flagged for recommended maintenance by LCSMC. Sediment from the banks can be eroded and easily transported downstream, directly into Loch Lomond. Bank stabilization maintenance, including stone toe protection, bank regrading, and native plantings, in this location could minimize future erosion and decrease sediment entering the lake. The model suggests that implementation of this project could potentially prevent 0.002 pounds of sediment per year from entering the lake.
